Z1315 WALL HYDRANT Exposed, Non-Freeze

ENGINEERING SPECIFICATION: ZURN Z1315

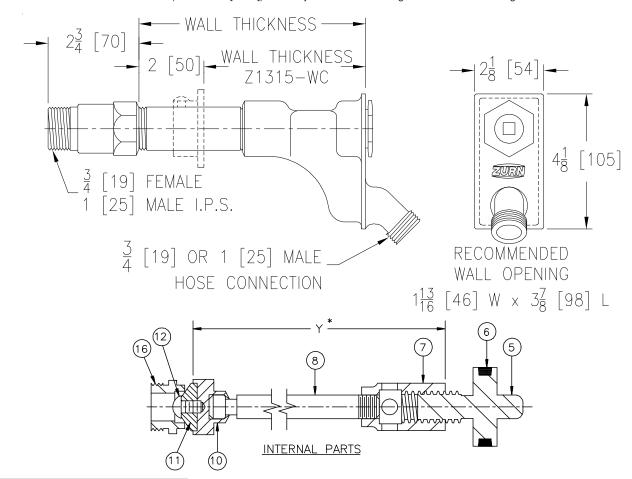
Exposed, non-freeze wall hydrant, with bronze casing, all bronze interior parts, nonturning operating rod with free-floating compression closure valve, replaceable bronze seat and seat washer, and combination 3/4 [19] female or 1 [25] male straight IP inlet. Complete with operating key.

<u>PARTS LIST</u>				
<u>ltem</u>	<u>Name</u>	<u>Quan.</u>		
<u>5</u>	Operating Screw	<u>1</u>		
<u>6</u>	<u>O-Ring</u>	<u>1</u>		
<u>7</u>	Operating Coupling	<u>1</u>		
<u>8</u>	Operating Rod	<u>1</u>		
<u>16</u>	Removable Seat	<u>1</u>		
<u>10</u>	<u>Washer Guide</u>	<u>1</u>		
<u>11</u>	<u>Washer (neoprene)</u>	<u>1</u>		
<u>12</u>	Screw	<u>1</u>

Wall Thickness Inches	Approx. Wt. Lbs. [kg]
4-6-8 [102-152-203]	6 [3]
10-12-14 [254-305-356]	8 [4]
16-18 [406-457]	10 [4]
20-22-24 [508-559-610]	12 [5]
